## Docket No. 217 - Development and Management Plan Inspection

Northeast Utilities Service Company Certificate of Environmental Compatibility and Public Need for the construction of a 345-kV electric transmission line and reconstruction of an existing 115-kV electric transmission line between Connecticut Light and Power Company's Plumtree Substation in Bethel, through the towns of Redding, Weston, and Wilton, and to the Norwalk Substation in Norwalk, Connecticut.

Date: September 29, 2005

**Location:** 115 kV Underground Route

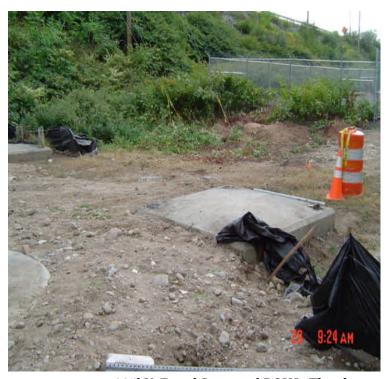
Areas of Inspection	Observation	Recommended Action
Broad Street/ROW, Norwalk	- The jack and bore under the railroad on Broad St. is ongoing. 9/29/05	-Activities were fairly well contained here. 9/29/05
	-A few sections of silt fence need repair along the ROW as a result of foundation construction here. 9/29/05	
Rt. 7, Norwalk	- Nightwork continues in several locations along Rt. 7. 9/29/05	-See storage sections regarding concrete disposal for this work. 9/29/05
Erosion and Sediment Controls (includes inspection within 24 hours of a storm event)	- For the most part, silt fence has been well installed in most locations where the work is located adjacent to wetlands and soils are being handled appropriately. 9/29/05	- Continue to be proactive in maintenance as necessary. See below for site-specific issues. 9/29/05

115kV (Broad Street and ROW): The photo on the left shows the corner edge of silt fence near the foundations at the substation which should be repaired. Photo on the right shows a spot along the ROW where the fence should be righted. (9/29/05)

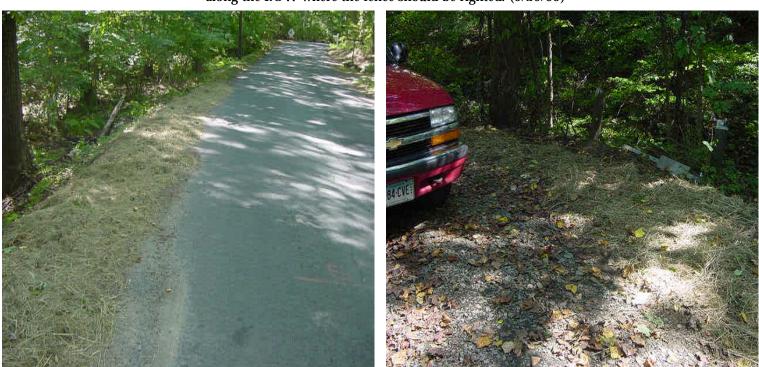
- Crews were still working within the manholes on Gallows Hill Rd. pulling cable. 9/29/05	-None at this time. 9/29/05
Gallows Hill Road and Rt. 107 (Lonetown Rd)	-Most of Gallows Hill is well restored with mulch and seed. Restoration efforts were made near #116, #86, and the original storage area near #84. Silt fence was pulled out. 9/29/05	- Continue to monitor and restored areas for final vegetation. 9/29/05.

115kV (Gallows Hill Rd): The photo on the left shows restoration efforts near #116. Photo on the right shows restoration at the original storage area near #84. (9/29/05)

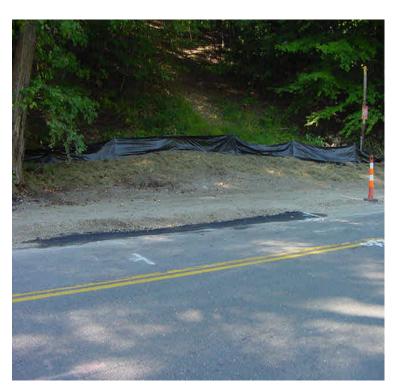
- A number of areas along Gallows Hill as well as on Rt. 107 (including the vault across from Jacob's Lane) have been restored. 9/29/05.	- Continue to send restoration crews out in time with D&M requirements and seed mulch areas where needed. 9/29/05.
Dewatering	- Almost all dewatering discharge along the route is being directed to frac trucks or tanks due to concerns about the polluted soils. 7/21-9/29/05  -Several tanks for dewatering are being stored at the Putnam Park storage area. 9/15-9/29/05	- It appears that the storage and disposal solution will continue due to concerns about the background pollutants in soils, even in those not considered contaminated. 7/21-9/21/05 It may be important to determine total daily volumes of water removal and evaluate whether this is a stress to the watershed or not a significant impact. 7/21-9/21/05
Blasting	- No blasting is occurring in any areas at this time.	- None at this time.

115kV (Rt. 58) The photo on the left shows the vault installation across from Jacob's Lane with restoration efforts. Photo on the right shows the Sunset Hill Rd storage area with appropriate controls. (9/29/05)

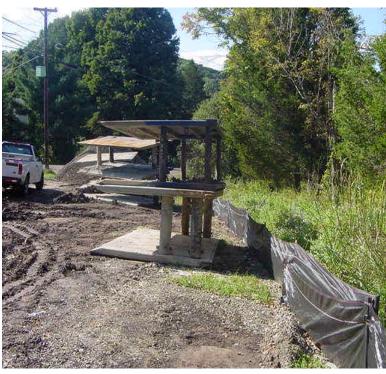
- The silt fence at the yard at the intersection of Rt. 58 and Sunset Hill Rd was well contained. The tracked area outside the fence was still noticeable. 9/21-9/29/05  - The Redding CC storage area fence remains well in place. 9/29/05	- Continue to maintain fence and treat it as a limit of work. Vehicles should stay within the fenced areas. 9/29/05 -None at this time. 9/29/05
State species of concern, threatened and endangered species	- No species of concern are located in the areas of construction.	- N/A
Vegetative clearing limits (including trees to save or danger trees noted)	- Mulching of bare areas is ongoing and should continue and areas should be seeded as necessary, especially the vault areas as they are the largest	- The D&M plan requires that disturbed areas to be left for more than 21-30 days before work returns here should be temporarily stabilized with

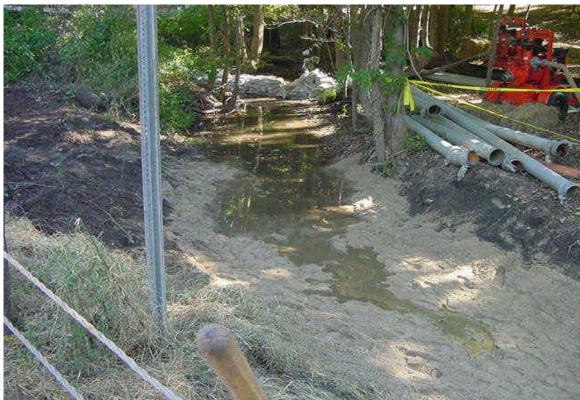
Adjacent Wetlands and Waterways	-The stream cut near Sara's Way off Rt. 58 has been completed well without any issues. Flow was just being allowed to return to the channel and the area was being restored. 9/29/05 - Check dams were located in the down stream portion to filter flow. 9/29/05	- None at this time, the restoration efforts look to be in good shape. 9/29/05

115kV (Rt. 58 Stream Cut) The stream cut at Sara's Way has been completed and restoration of the area was in progress. Water was just beginning to be released to the stream channel. (9/29/05)

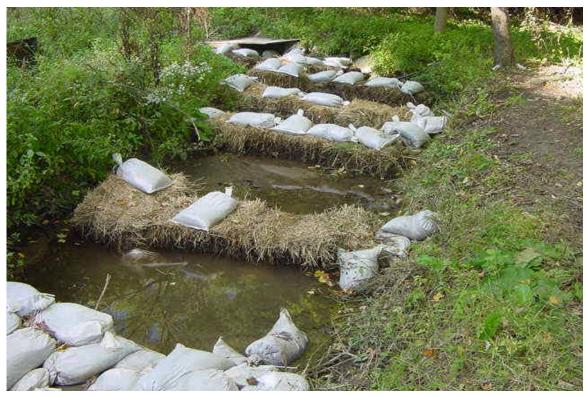
View downstream of the work. A number of check dams were placed to filter the stream flow. (9/29/05)

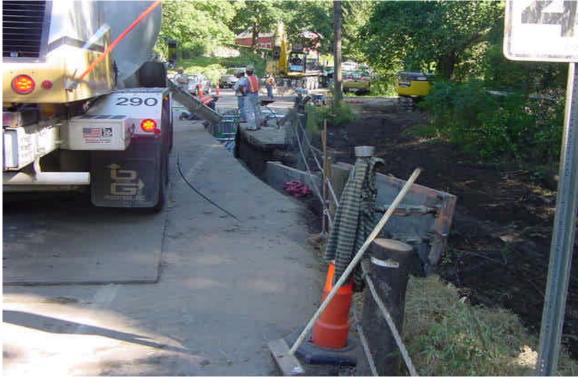
View of the trench work returning to the roadways adjacent to the stream cut. (9/29/05)

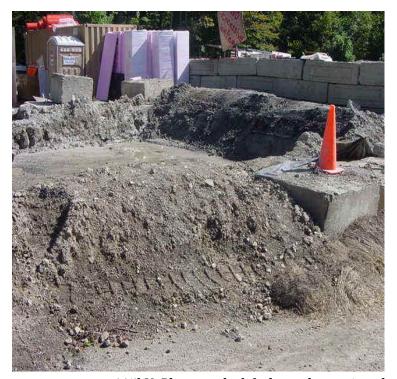
115kV: Photo on the left shows the continued good containment of the concrete washout at the Redding Town Yard. Photo on the right shows where the southern gully in the ROW has been repaired at Bethel Educational Park. (9/29/05)

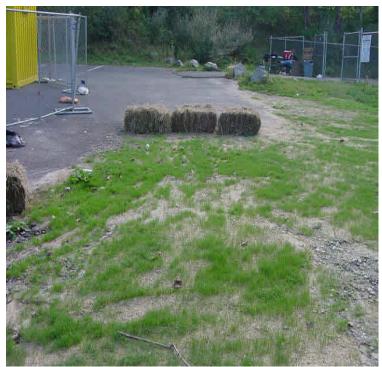
115kV (Bethel Ed. Park): Photo on the left shows haybale check dams placed in an attempt to slow stormwater flow to the ROW. The photo on the right shows the good grass growth at the northern end of the ROW. (9/29/05)
